Washington County, Tennessee Corridor Safety Analyses and Recommendations Final Report

Prepared for the Federal Highway Administration by:
VHB

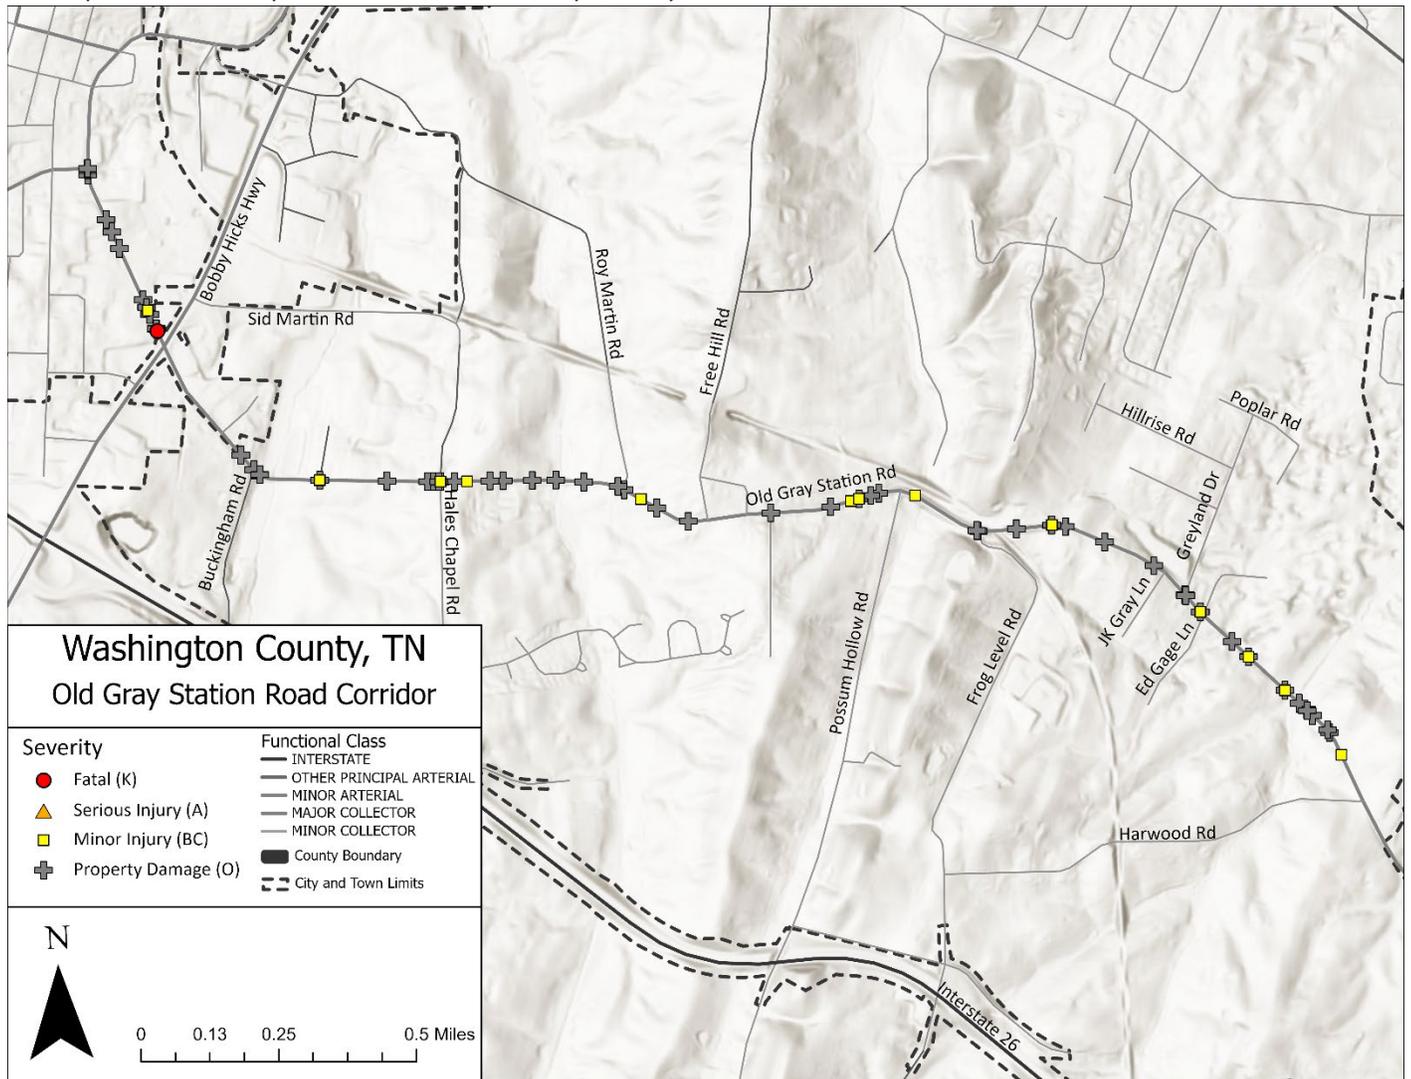
Intersection crashes account for the highest percentage of all severe crashes within the studied emphasis areas on this corridor, at 47 percent. This is followed by roadway departure and speeding/aggressive driving, which account for 37 percent and 34 percent of all crashes, respectively.

Figure 3: Old Gray Station Road Corridor Overview (Source: FHWA, 2022)

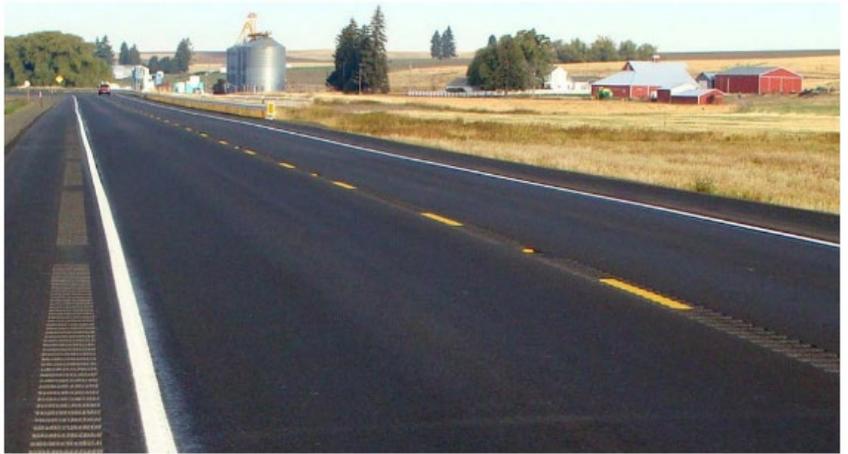
Old Gray Station Road has several horizontal curves. For example, at Old Gray Station Road and Roy Martin Road, there have been four crashes, three of which involved roadway departure. Strategies to keep the vehicles on the roadway on a curve or to reduce the severity of a crash once the vehicle leave the road include: widening shoulders, flattening sideslopes, maintaining the clear zone, installing curve warning and chevron signage, implementing retroreflective pavement markings, installing center and edgeline rumble strips, widening edgelines and applying SafetyEdgeSM treatments. Location of rumble strip implementation will also depend on proximity to residential properties due to noise from their operation.

Figure 21: Edge and centerline rumble strips (Source: FHWA)

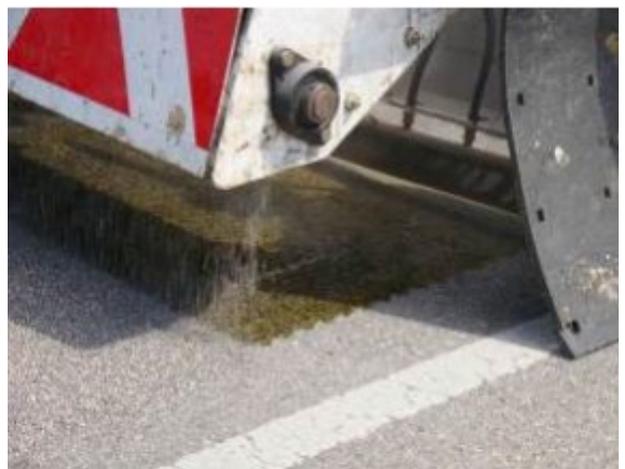
Of the 15 wet-weather crashes that occurred on Old Gray Station Road, four of them also involved roadway departure. High Friction Surface Treatment (HFST) is effective in reducing run-off-road and wet weather crashes but has also been shown to reduce dry weather and head-on sideswipe opposite direction crashes. HFST locations are

Figure 22: High Friction Surface Treatment (Source: Meritt et al. 2020a)

typically selected based on high crash rates, although HFST has also been used as a systemic treatment countermeasure. FHWA research shows that HFST has a lifecycle of approximately 10 years.²

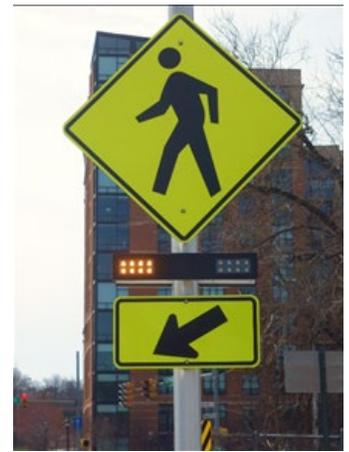
Figure 24: Rectangular Rapid Flashing Beacon (Source: FHWA MUTCD)

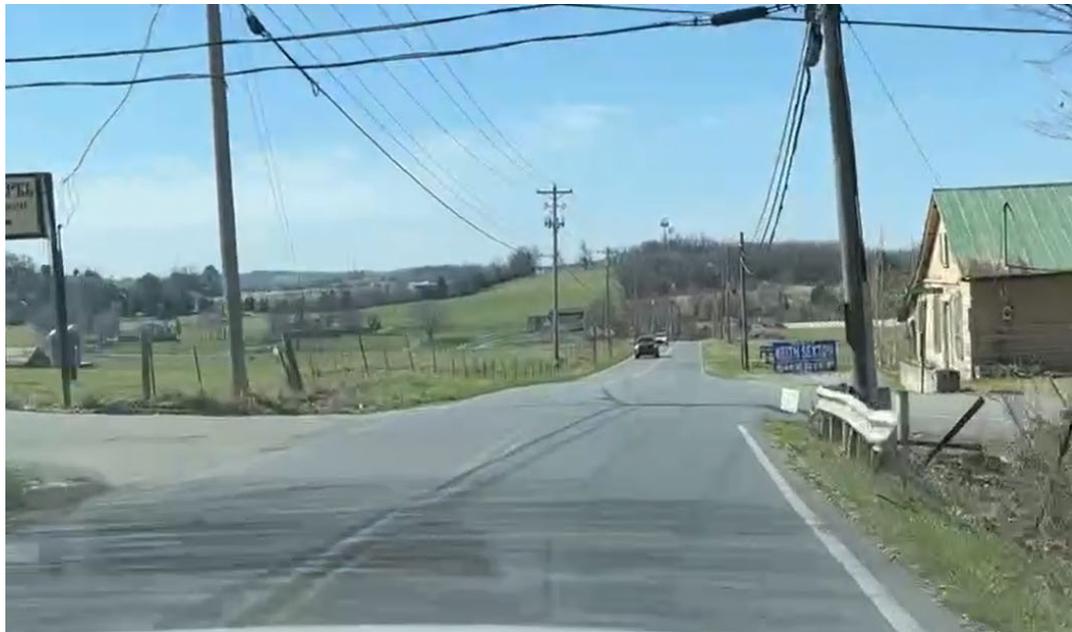
During the study period, twenty-four crashes occurred at the intersection of Old Gray Station Road and Hales Chapel Road/Sid Martin Road and three others occurred within 150 feet of the intersection. There are several contributing factors that may have caused this location to become a hotspot for crashes. The north-south connections, Sid Martin Road and Hales Chapel Road, are not aligned. The Sid Martin Road approach has poor visibility looking eastward due to vegetation, a utility pole, and a nearby crest on Old Gray Station Road. Traveling in a westerly direction along Old Gray Station Road, the exposed end treatment on the guardrail on the right side of the road presents a road departure hazards to motorists. Traveling in an easterly direction there is a utility pole on the right side of the road that likewise presents a roadway departure hazard for motorists.

Figure 26: Intersection of Old Gray Station Road and Hales Chapel Road/Sid Martin Road (Source: FHWA)

Remediations include installing intersection ahead signs, establishing a four-way stop intersection, installing rumble strips on the mainline approaching the intersection, and reconfiguring the intersection so that the minor roads align. Having guardrails that are in place and well-maintained is also recommended.

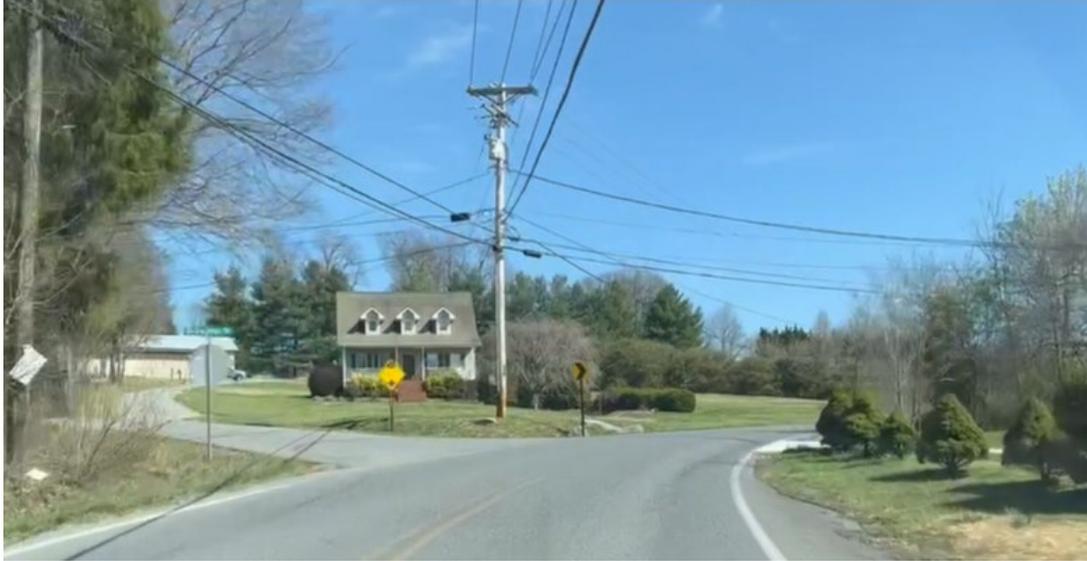
Twenty-two of the 41 roadway departure crashes involved a driver negotiating a curve. This site has had three roadway departure crashes during the study period. Rumble strips that help delineate the edges and center of the roadway are recommended. Additional recommendations are to widen shoulders, flatten sideslopes, maintain the clear zone, and install additional chevron or advance curve warning signs.

Figure 27: Horizontal curve at the intersection of Old Gray Station Road and Roy Martin Road (Source: FHWA)

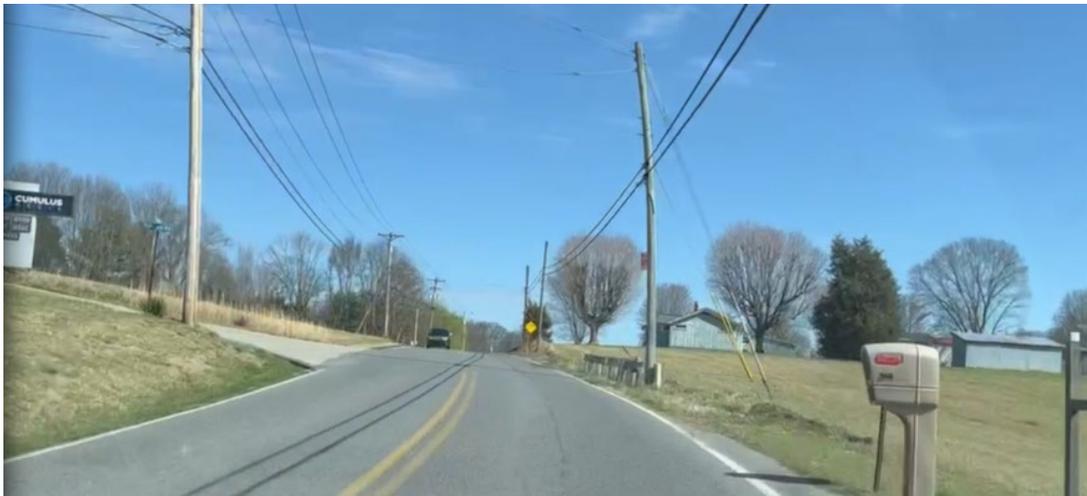
The guardrail at this location does not properly protect motorists from striking the roadside utility pole. Extending the guardrail section closest to the utility pole and installing proper end treatments is recommended.

Figure 28: Guardrail at the intersection of Old Gray Station Road and Free Hill Road (Source: FHWA)

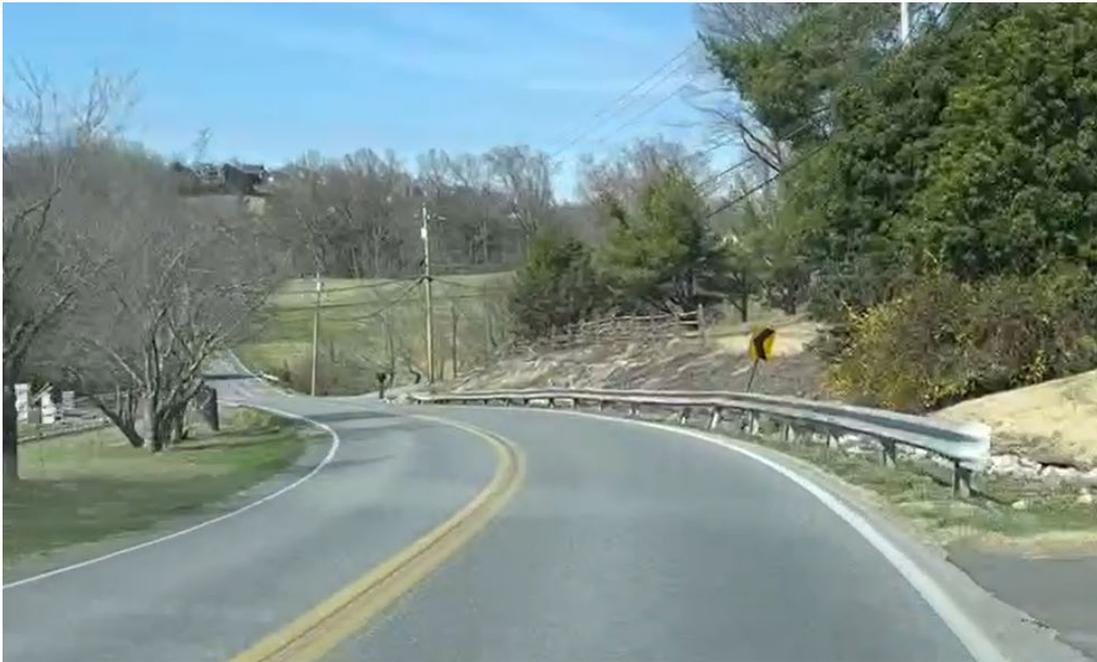
Traveling west, the guardrail end treatment at this location does not properly protect motorists who strike that section of the guardrail. Adding proper guardrail end treatments is recommended. Enhancing the visibility of the curve by repairing existing chevron signage and adding additional chevron and curve warning signs is also recommended.

Figure 29: Guardrail located at coordinates 36.40023925363636, -82.43532453803012 (Source: FHWA)

Site	Site-Specific Location (Geographic Coordinates)	Countermeasure	Cost (Low/Medium/High)	CMF Rating/CTW Rating	CMF ID	Source (e.g., Proven Safety Countermeasure)	Timeline
	Harwood Road and Ed Gage Lane, (Westbound, see Figure 29.)	Replace Metal-beam guardrail					
4	Old Gray Station Road, between Harwood Road and Ed Gage Lane, (Westbound, see Figure 29.)	Enhanced Delineation for Horizontal Curves: Chevron Signs	Low	★ ★	9726	FHWA Proven Safety Countermeasures	Short-term

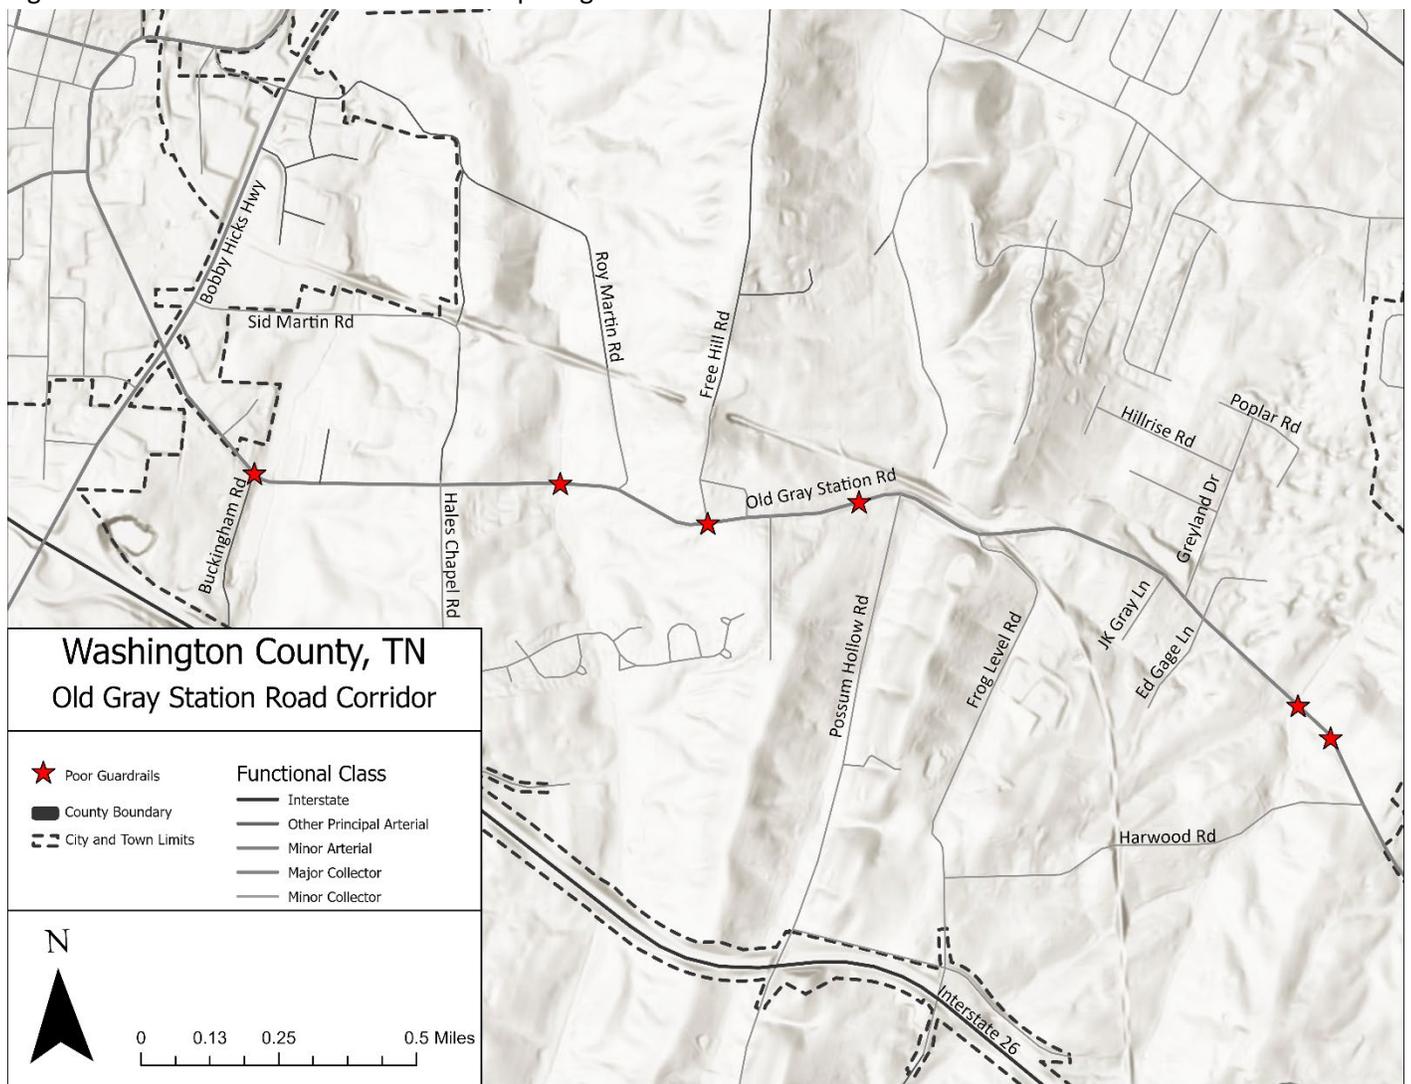
Figure 30 shows locations where there are poor guardrail treatments:

Figure 30: Poor guardrail treatments on Old Gray Station Road (Source: FHWA)

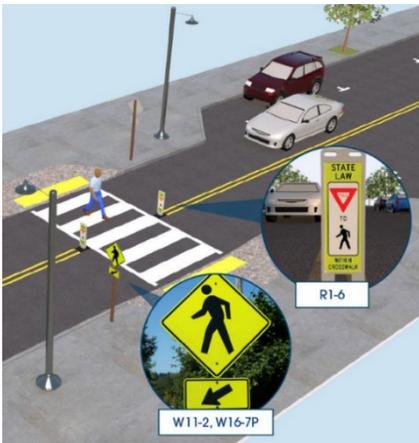
Figure 31: High-visibility crosswalk (Source: FHWA)

Upgrading the current crosswalk at Gray Elementary School (Figure 32) with high visibility design elements help it stand out to motorists, like the example shown in Figure 31. Other enhancements in the vicinity of the crosswalk include pedestrian crossing signs, high-visibility treatments to existing school zone signage, flashing warning signs, and speed feedback signs. This can potentially provide a safer environment for children to cross Gray Station Road.

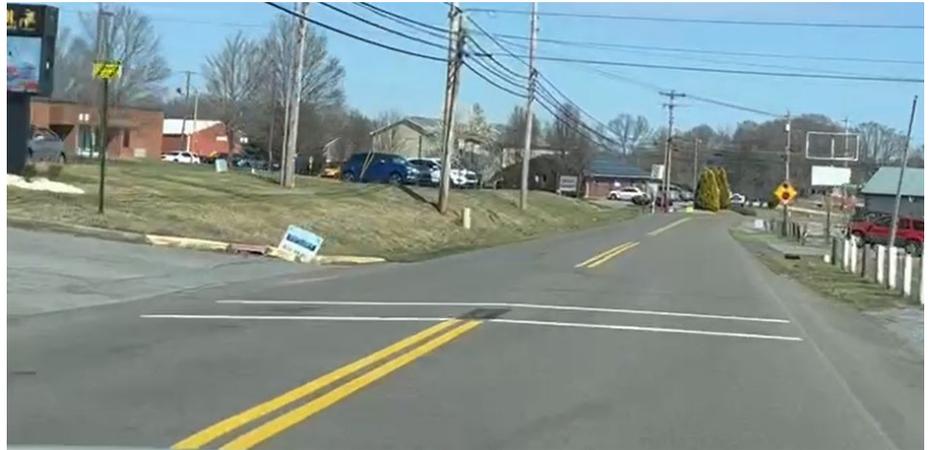
Figure 32: Crosswalk on Gray Station Road, located at approximate coordinates 36.41595382316783, -82.47767720708008 (Source: FHWA)

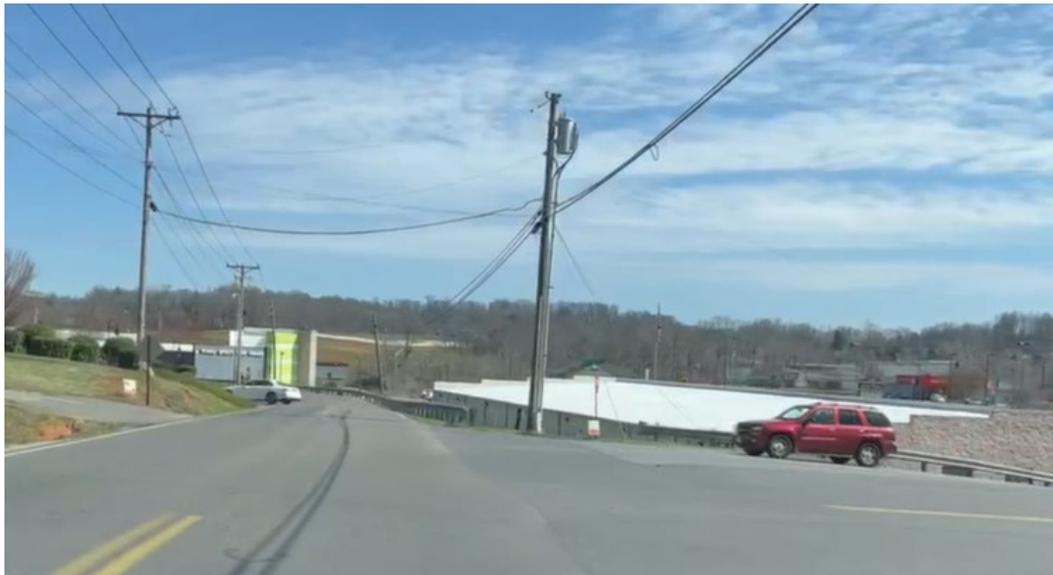
This northbound location on Gray Station Road at the intersection with Judge Gresham Road and Roy Martin Road is a crash hotspot for multiple emphasis areas. Three crashes occurred at the intersection and four others occurred within 200 feet east of the intersection. Crash types include three rear-end, two angle, one opposite direction sideswipe, and one single car roadway departure crash. The layout of this intersection may be causing confusion for motorists. The proximity to a curve and poor sightlines may be contributing factors which have resulted in this intersection becoming a crash hotspot. In the long-term, access could be redesigned with consolidated approaches to improve safety at this intersection. Short-term solutions include warning signage, transverse rumble strips on the Gray Station Road approach, and introduction of a four-way stop. Location of rumble strip implementation will also depend on proximity to residential properties due to noise from their operation.

Figure 33: Corner of Gray Station, Judge Gresham Road, and Roy Martin Road (Source: FHWA)

2	Intersection of Gray Station Road and Judge Gresham Road/Roy Martin Road (See Figure 33.)	Four-way stop	★ ★ ★	3130	Low/medium	FHWA Proven Safety Countermeasures	Medium-term
3	Gray Station Road between Roscoe Fitz Road and Hill Street (See Figure 36.)	Roadway Design Improvements: Replace/Install Metal-beam Guardrail end treatments	★ ★ ★	10306	Low/Medium	FHWA Proven Safety Countermeasures	Short-term

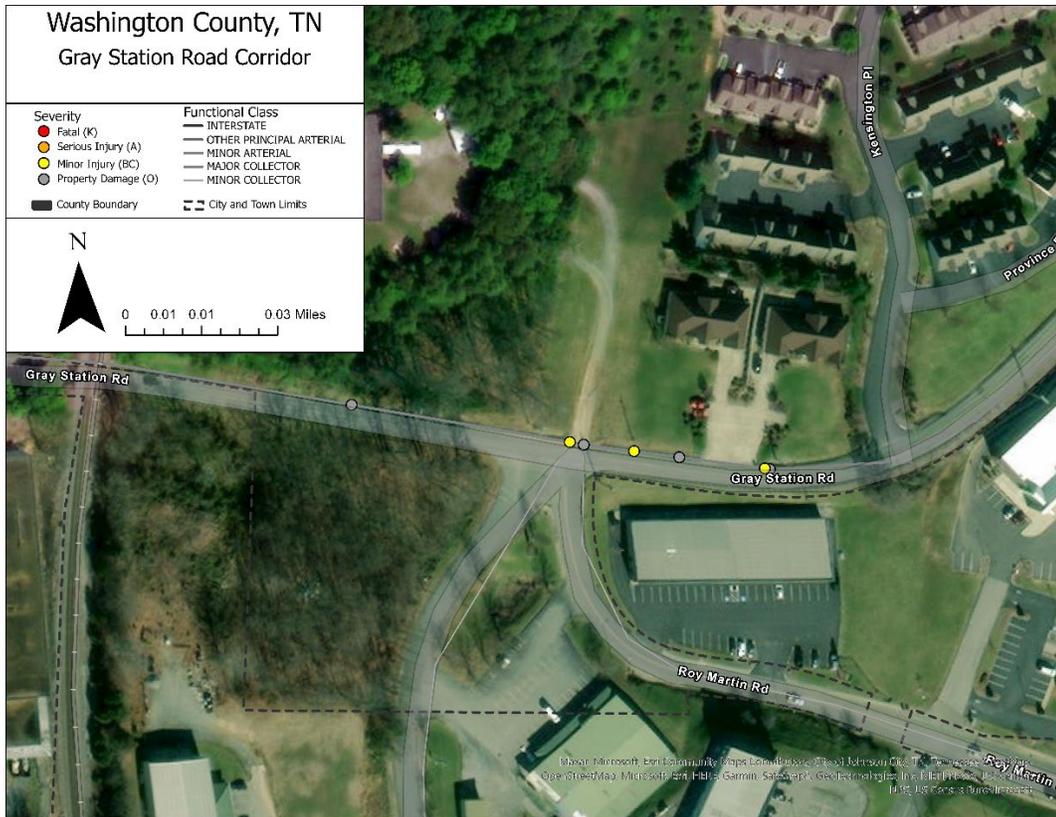
Figure 34: Intersection of Gray Station Road, Judge Gresham, and Roy Martin Road (Source: FHWA)

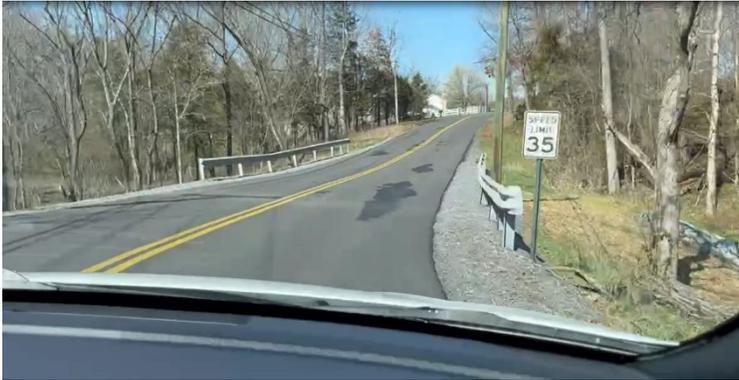
This southbound location on Gray Station Road, approximately 185 feet north of Roscoe Fitz Road, has two guardrails with improper end treatments. Without proper end treatments, guardrails can be less effective at preventing vehicles from running off the roadway and the existing end treatments present additional safety concerns to motorists. If a motorist were to strike the end of the guardrail head-on, the guardrail may not buckle and redirect as it is designed to, but instead impale the vehicle, potentially harming any occupants.

Figure 36: Guardrails near the intersection of Gray Station Road and Roscoe Fitz Road, at coordinates 36.40401965354401, -82.49215650991447 (Source: FHWA)

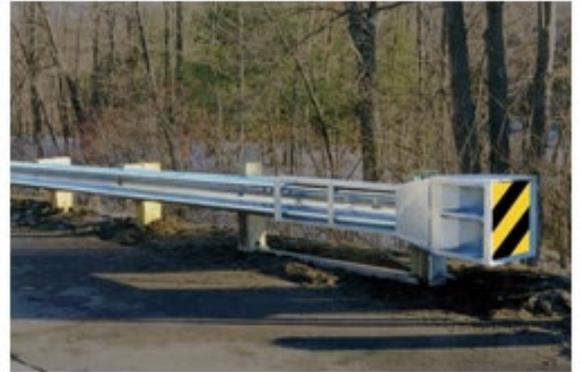
Figure 35: Energy-absorbing end treatment (Source: FHWA, W-Beam Guardrail Repair)

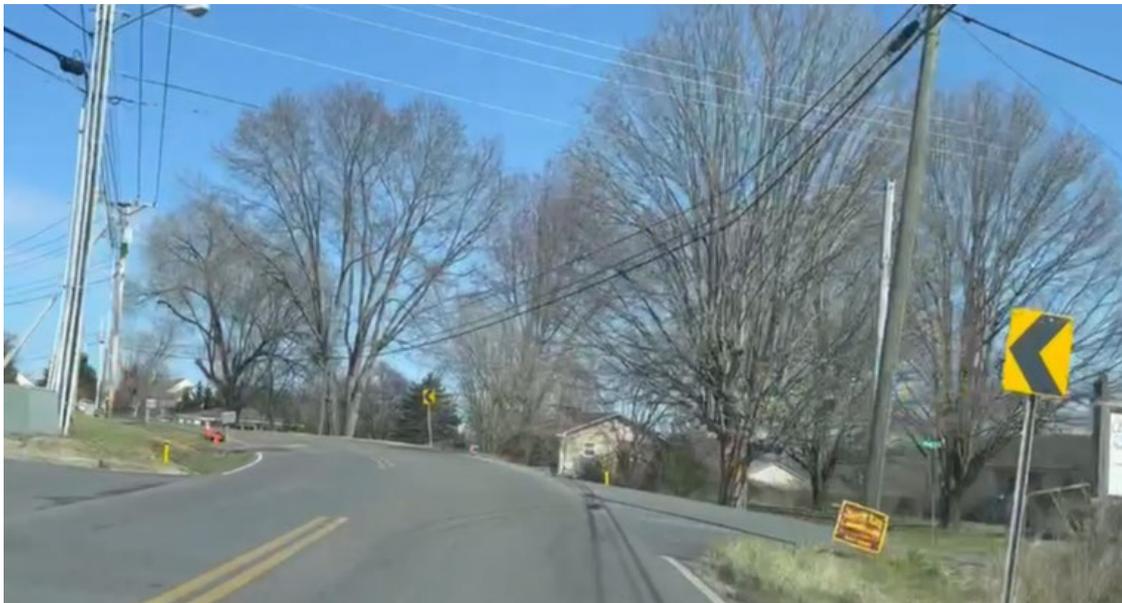
Four of the seven roadway departure crashes at this location, near the intersection of Gray Station Road and Crystal Springs Circle, have occurred during wet-weather conditions. High-friction surface treatment application is recommended to reduce instances of skidding off the roadway. Additional recommendations are slippery road warning signs, transverse rumble strips, and speed feedback signs. Location of rumble strip implementation will also depend on proximity to residential properties due to noise from their operation.

Figure 37: Horizontal curve at the intersection of Gray Station Road and Crystal Springs Circle, at approximate coordinates 36.42842186393448, -82.46123884162745 (Source: FHWA)

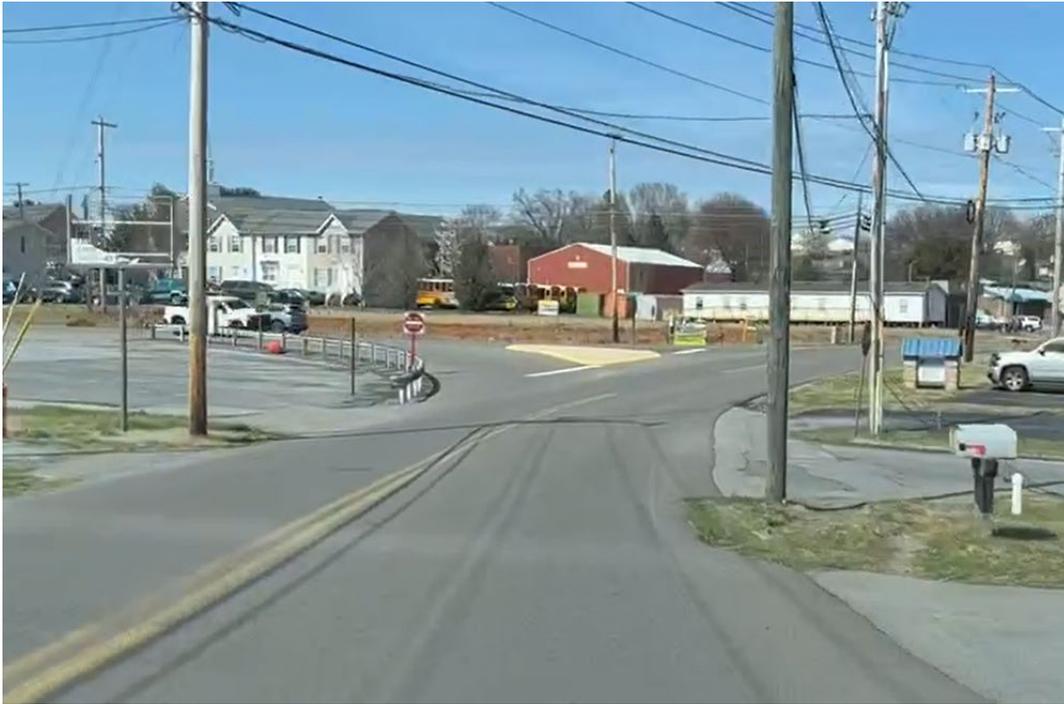
This intersection of Gray Station Road and Old Gray Station Road has been a crash hotspot during the period studied with eight property damage crashes. Replacing the stop-controlled intersection with a roundabout is a long-term solution to reducing crashes at this site. Short term solutions include the installation of an all-way stop control.

Figure 38: Corner of Old Gray Station Road and Gray Station Road (Source: FHWA)

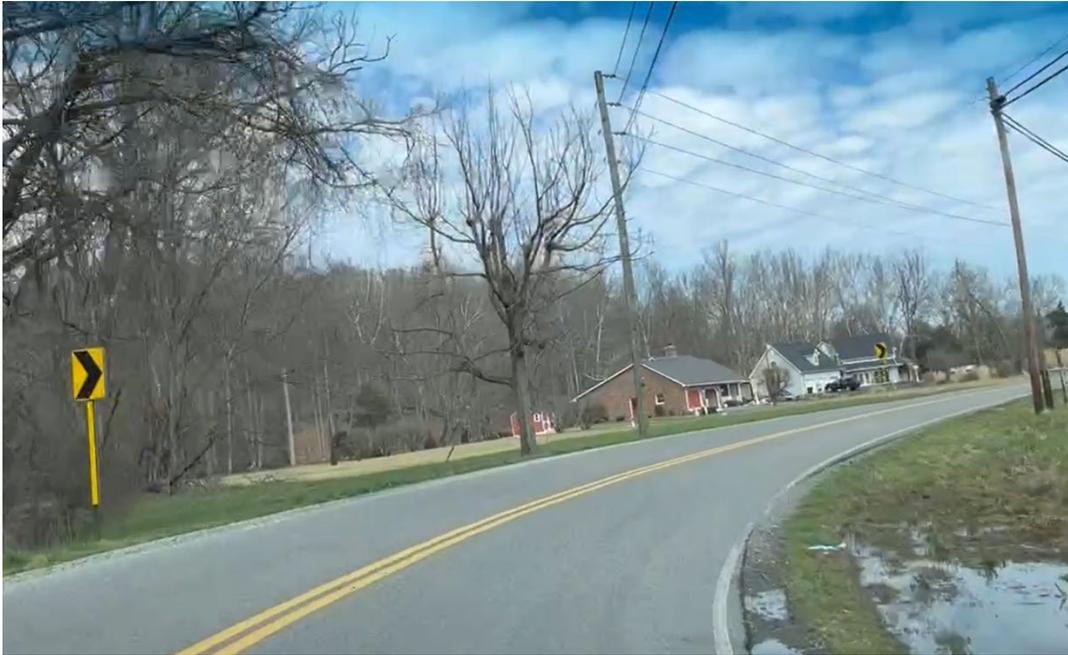
This horizontal curve near 4490 Greenwood Drive has been the site of multiple roadway departure crashes. Five crashes were recorded at this location including a motorist striking a utility pole. Implementing the following countermeasures has the potential to improve safety at this location: Maintaining the vegetation in the clear zone, relocating utility poles outside the clear zone, installing chevrons to adequately delineate the curve, widening the shoulder in both directions, and installing SafetyEdgeSM treatment.

Figure 40: Horizontal curve located near coordinates 36.24745067319022, -82.45597961070588 (Source: FHWA)

1, 2	Near 4490 Greenwood Drive (Northbound, see photo 40), Near 4670 Greenwood Drive (Northbound, see photo 41)	Roadway Design Improvements - SafetyEdge SM	★ ★ ★ ★ ★	8661	Medium/High	FHWA Proven Safety Countermeasures	Long-term
3	Greenwood Drive, between Cecil Gray Rd and Mill Springs Rd (Northbound, see photo 42)	Roadway Design Improvements: Replace and extend metal-beam guardrail with appropriate end treatment and add to other side of the road.	★ ★ ★	10306	Low/Medium	FHWA Proven Safety Countermeasures	Short-term

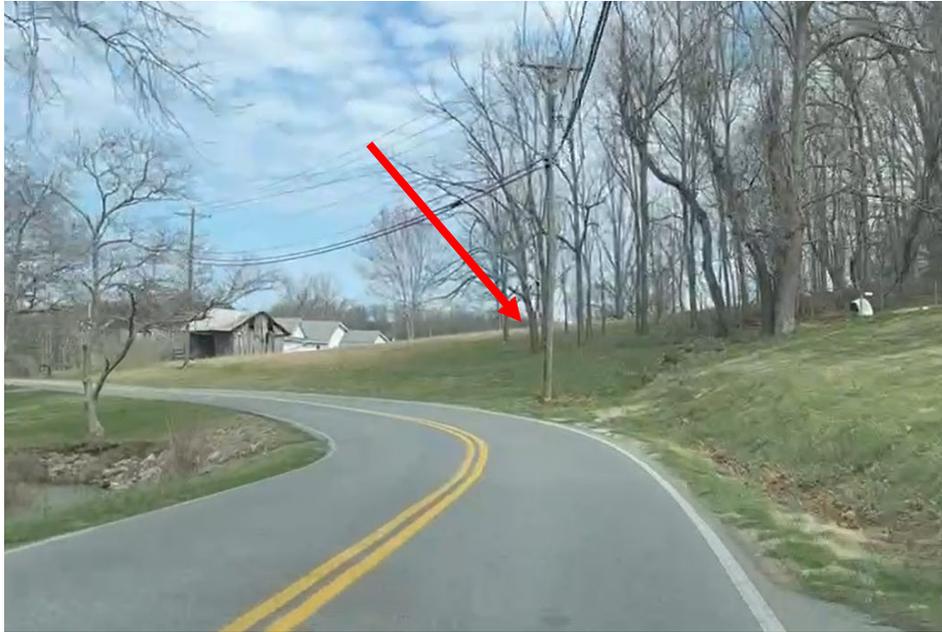
There has been one crash at this location near 4670 Greenwood Drive involving a driver striking a utility pole. The utility pole in this location is located within the clear zone and if possible it should be relocated, or otherwise protected by a guard rail. Additionally, there are no curve warnings in the southbound direction, and only a curve-road sign in the northbound direction. Adding chevron signs further delineate the curve and it is also helpful to install advance curve warning signs in both directions.

Figure 41: Horizontal curve located near coordinates 36.24136900224054, -82.46150468997978 (Source: FHWA)

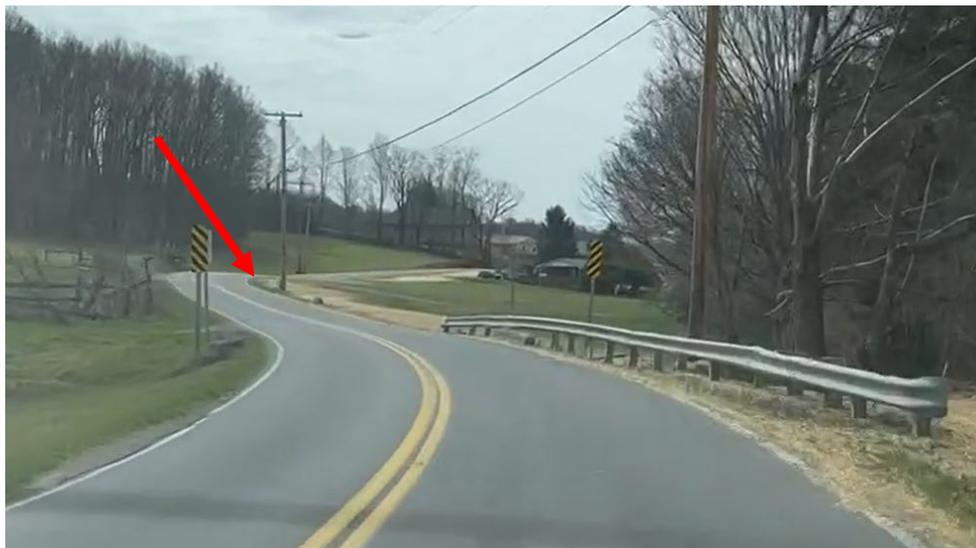
This southbound location on Greenwood Drive near Cecil Gray Road is the site of three crashes. Two have involved drivers striking the utility pole that is identified in figure 42. Removing and/or relocating the utility pole and any other fixed objects from the clear zone is recommended. If that is not possible, adding a guardrail -- like the one seen in the photo -- is recommended. Installing advance curve warning signs and chevrons help to delineate the curve and enhance driver awareness and visibility.

Figure 42: Guardrail and horizontal curve located near coordinates 36.25772966043992, -82.43038290368362 (Source: FHWA)

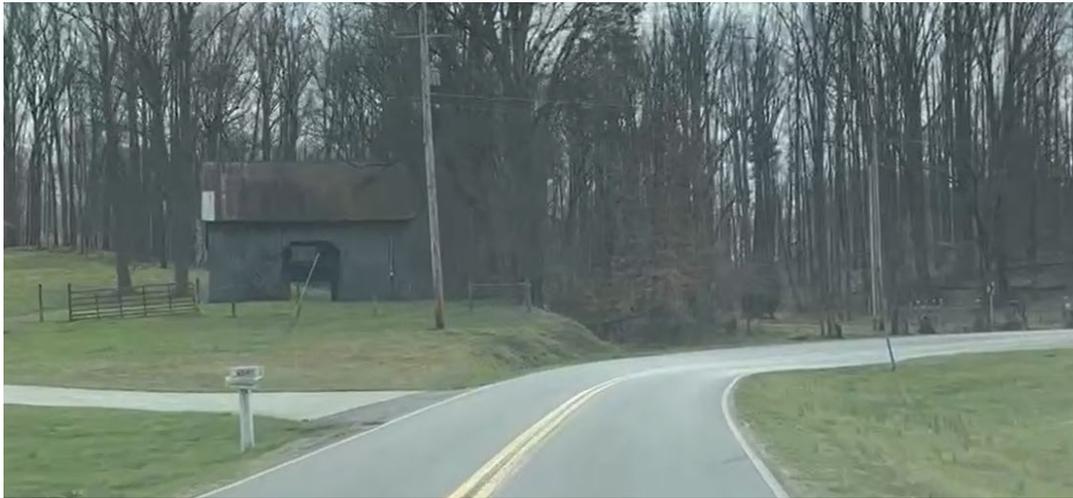
Five crashes occurred within 180 feet of this curve near Rock Church Road. Two of those crashes involved speeding/aggressive driving. In the southbound direction, there is a lack of warning for this curve. Advance curve warning signs and/or pavement markings are recommended to help delineate the curve. Additional chevron signage is also recommended.

Figure 43: Horizontal curve located near coordinates 36.246394061855256, -82.45570999655796 (Source: FHWA)

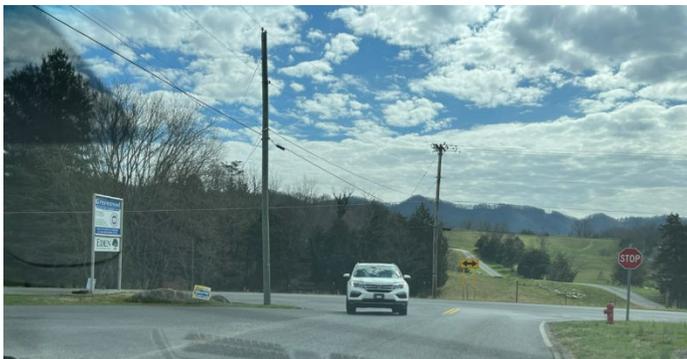
There have been three crashes at the intersection of Greenwood Drive and Mill Springs Road. Two others have occurred within 200 feet of the intersection. A sixth crash was recorded at the intersection of Summit Drive and Mill Springs Road. The current intersection design involves difficult sightlines and approaches that confuse motorists and increase the likelihood of crashes. A long-term goal of consolidating or reconfiguring the access to Greenwood Drive could reduce conflict points, simplify the approach, and improve safety at this intersection. Short-term recommendations include signage on Greenwood Drive to indicate the intersecting streets extending from the intersection.

Figure 44: Corner of Greenwood Drive and Mill Springs Road (Source: FHWA)

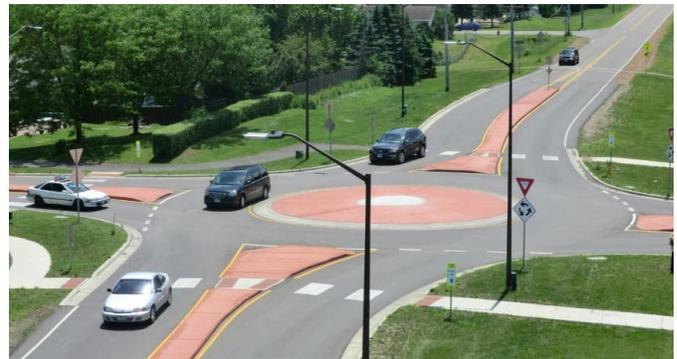
Figure 45: Roundabout (Source: FHWA)

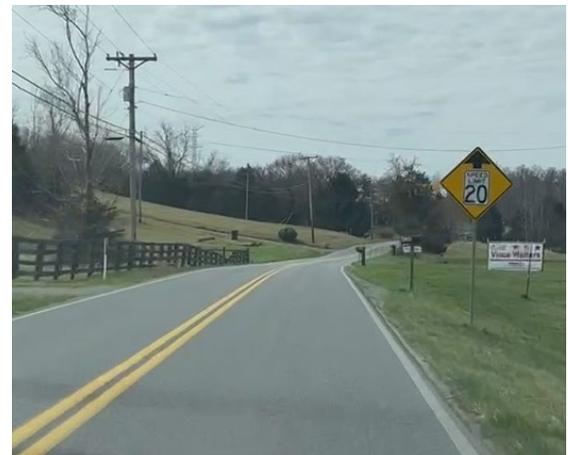
Figure 46: New signage on Greenwood Drive near Brethren Church Drive
